# BROOKLYN ELEVATED TRAIN DERAILMENT

COMPILED BY MEMBERS OF RESCUE 3 OF THE  
CITY OF NEW YORK (NY) FIRE DEPARTMENT  
WHO RESPONDED TO THIS INCIDENT

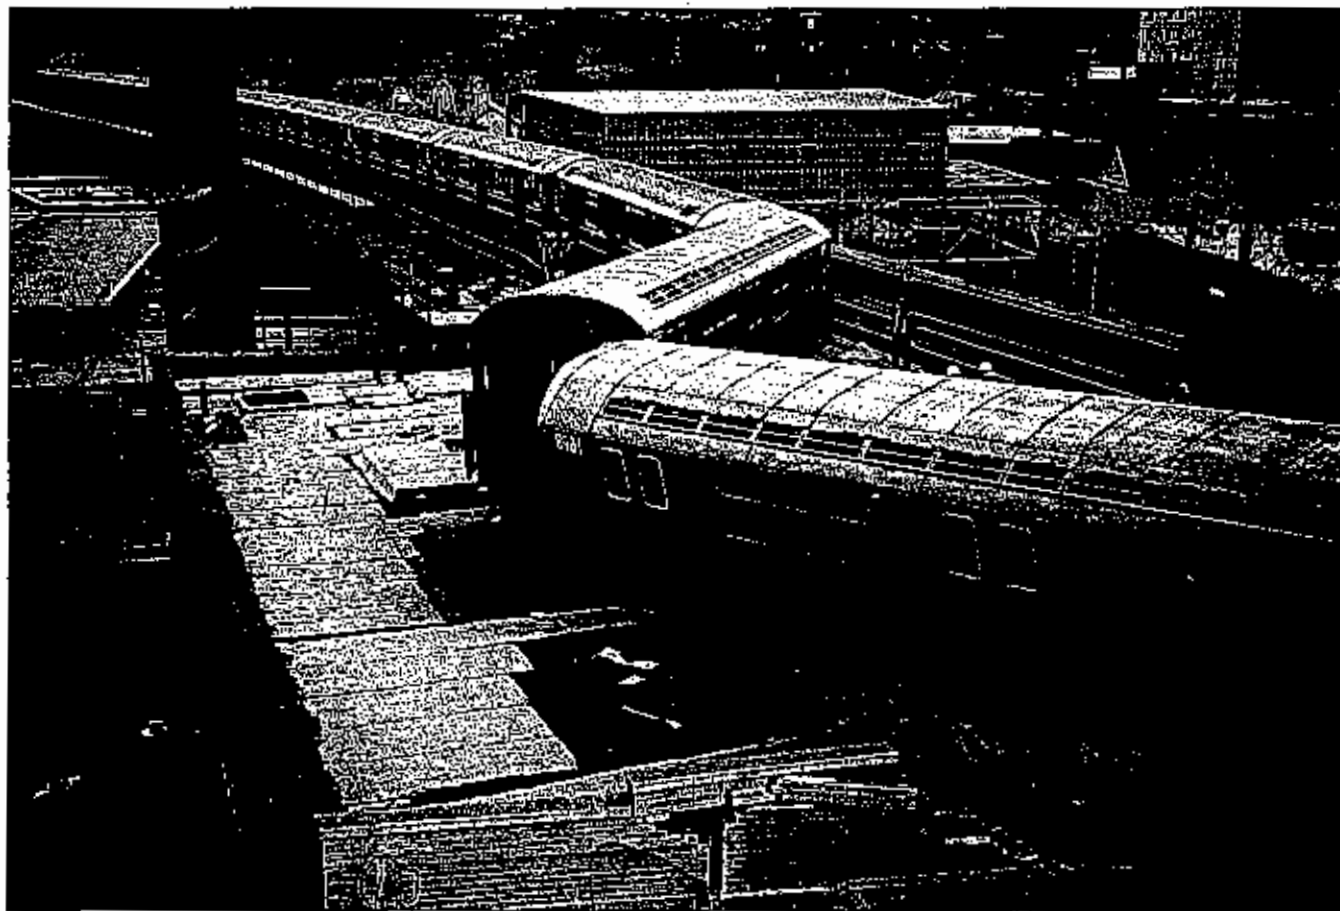
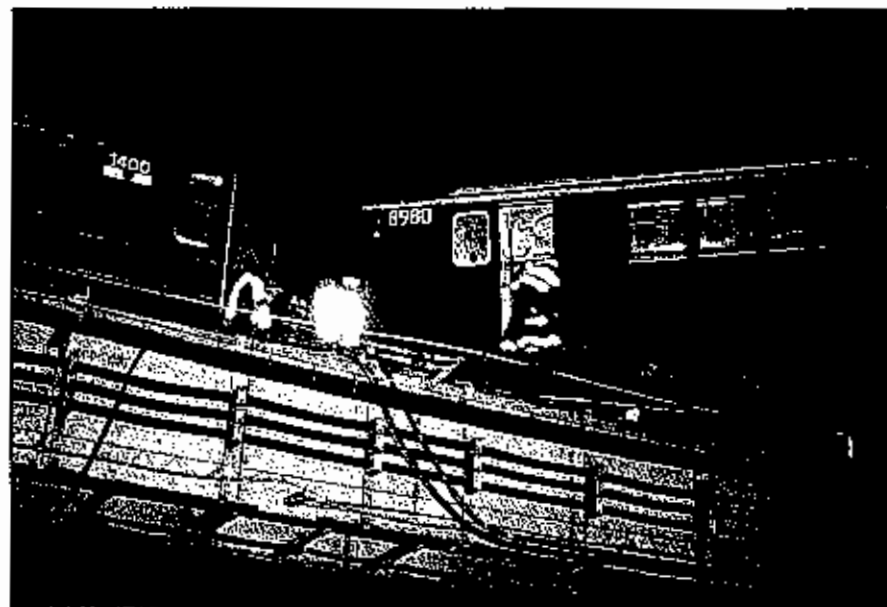
Cars 3 and 4 fell onto a parked tractor trailer, bringing down with it the electrified third rail, which set the trailer contents (cardboard) on fire. (Top photo by Ray Dawney; bottom photos by Matthew P. Daly.)

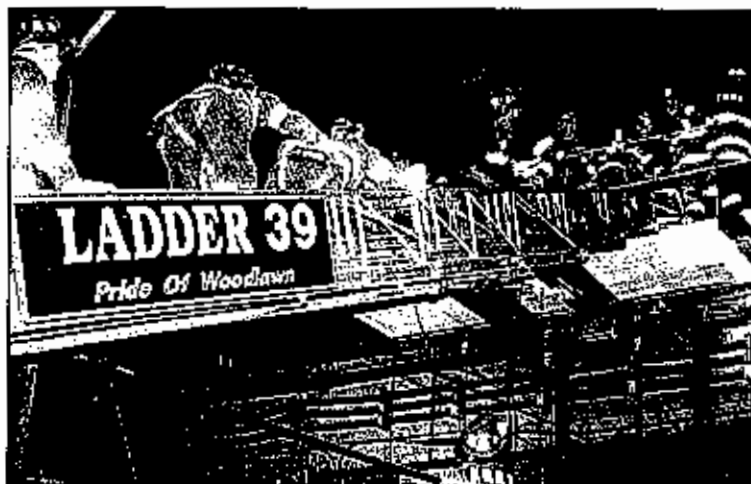
The packaged victim is brought to awaiting medical personnel via tower ladder and a simple rope system. (Photos by Matthew P. Dely.)
