TIMES SQUARE SCAFFOLDING COLLAPSE

BY RAY DOWNEY

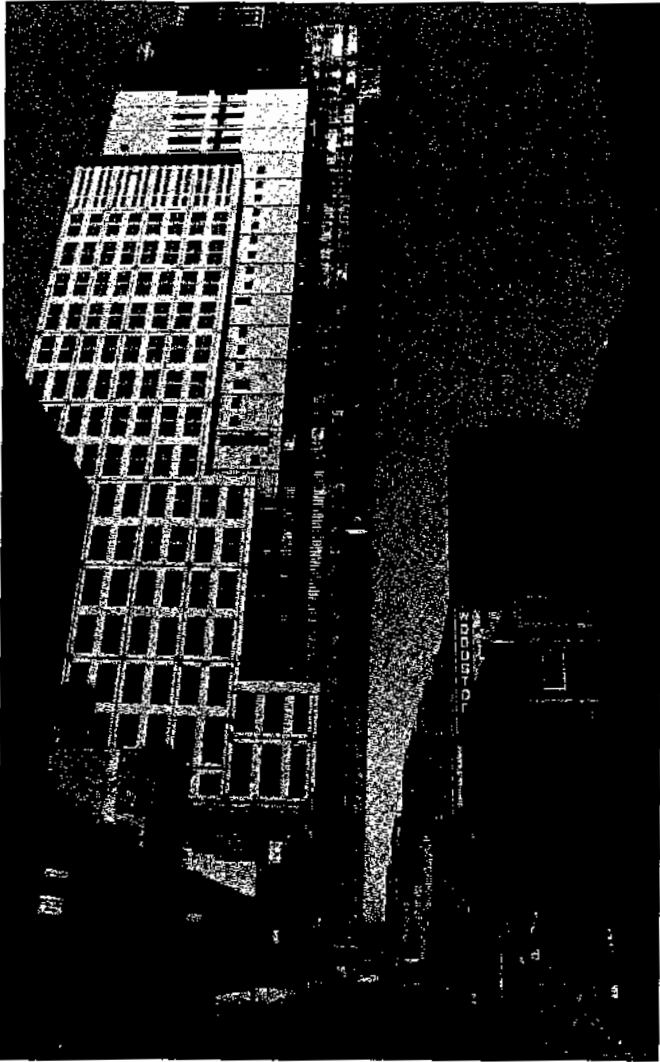
(Top left) A 50-story scaffolding collapsed at the 19th floor of the Conde Nast building, under construction, at 4 Times Square in New York City. Another scaffolding is directly behind the collapsed scaffolding; it looks like part of the collapsed scaffolding. (Top right) Collapsed track used to carry elevator cars at street level. (Bottom right) Note the missing track on which the hoist car rode. Those sections landed on the street and a hotel across the street. (Photos courtesy of Fire Department of New York.)

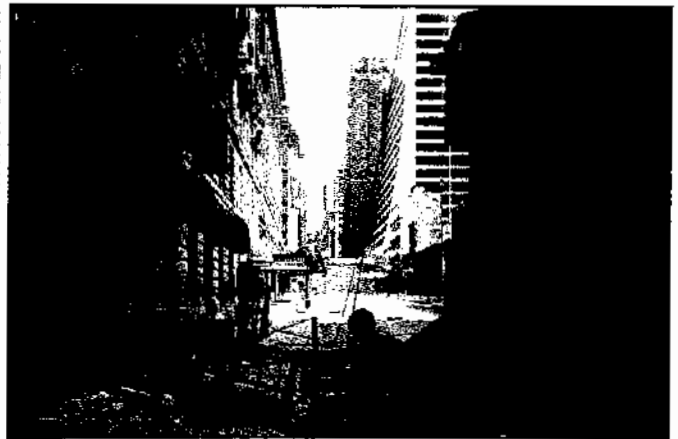
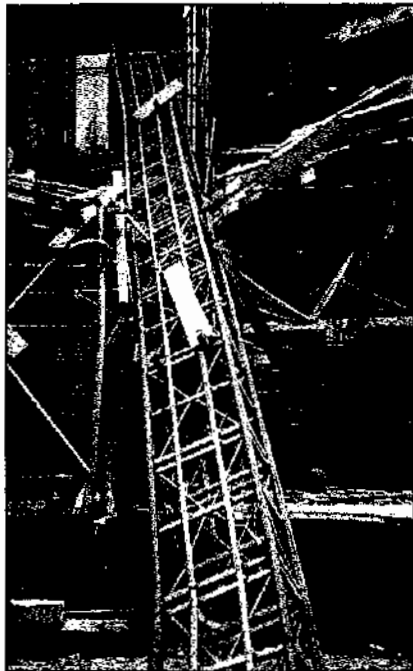
(Top left) This section of track crashed through the roof of the Hotel Woodstock, dropping ceiling and roof material. The elderly occupant of the top-floor apartment directly below was killed. (Top right) Part of the collapsed track landed in the street directly below the collapsed scaffolding. (Bottom left) Debris and parts of the hoistway car landed on the roof of a hotel across the street from the collapsed scaffolding. (Bottom right) This section of track dropped from floors above the 20th floor to the street. (Photos by author.)

The largest section crashed through the roof of the 12-story Hotel Woodstock, located across the street from the scaffolding. This section penetrated the reinforced concrete roof of the hotel, killing the elderly occupant of Room 1202 on the top floor. Damage to the cars on the garage roof and a section of the roof was significant. The counterweight for one of the cars was imbedded deep into 43rd Street.

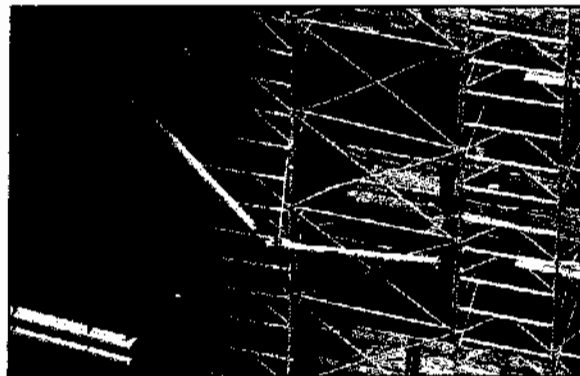
(Left) Close-up of the damaged scaffolding and broken horizontal supports. (Top right) This horizontal support was broken in half. These supports provided stability to the scaffolding at each floor. (Bottom right) Transits were set up to monitor the movement of the scaffolding. Firefighters with radios stationed at the transit sites were instructed to notify the command post if any movement was observed. (Photos courtesy of Fire Department of New York.)

folding, knew why the collapse had occurred. A number of reasons were offered. One witness reported that he saw the crane on the building's roof strike the elevator track while lifting a load of material. This report was discounted. Another possible explanation was that some nuts and bolts were missing from the elevator hoisting system and the scaffolding was faulty, thereby causing it to fail and put intense pressure on the elevator track. The explanation getting the most attention was that some of the horizontal supports had been removed to put glass panels in place and had not been replaced by the time of the collapse. The report was still being investigated at the time this article was prepared.

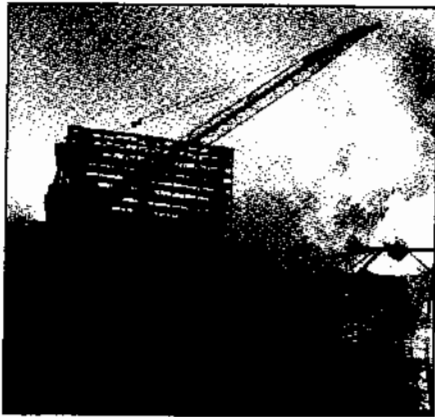
(Above) The structural steel, 36-square-foot box that would support the curtain (the netting enclosure around the scaffolding to prevent additional debris from falling from the upper floors) is set on the A-frame. Four steel cables supported the box, which was suspended from a ring in the A-frame. The netting was attached to 10 cables and then secured to the box. (Right) Close-up of the A-frame being set in place at roof level. (Photos by author.)

The plan adopted involved constructing a 36-square-foot box of structural steel to support the curtain, which would be held by an A-frame, also constructed of structural steel. The unit would be fabricated on the roof and set in place at a 28-degree angle over the scaffolding. The box was suspended from a ring on the A-frame by four steel cables. Ten cables to which the netting would be attached were then secured to the box. The cables were put in place in a "balanced" sequence to maintain the system's stability. The primary objective was to prevent the scaffolding and debris from becoming dislodged. Construction workers operated in baskets secured to the crane's main line. Radios and hand signals were used to ensure workers' safety while they attached the cables to the box.
