# TIMES SQUARE SCAFFOLD COLLAPSE

by Battalion Chief Raymond M. Downey

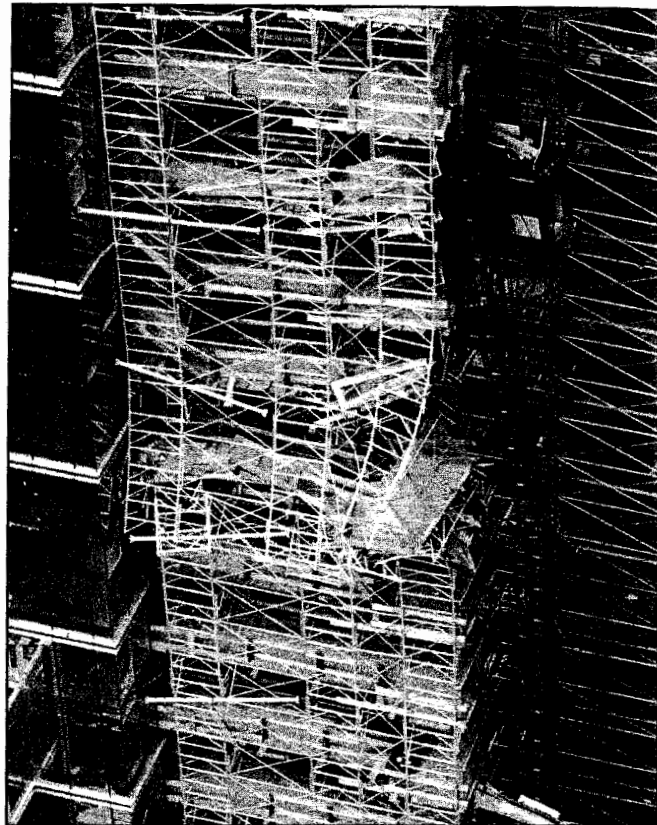
The scaffold collapse that tied up the Times Square area for 29 days and kept FDNY units on the scene for 26 days.

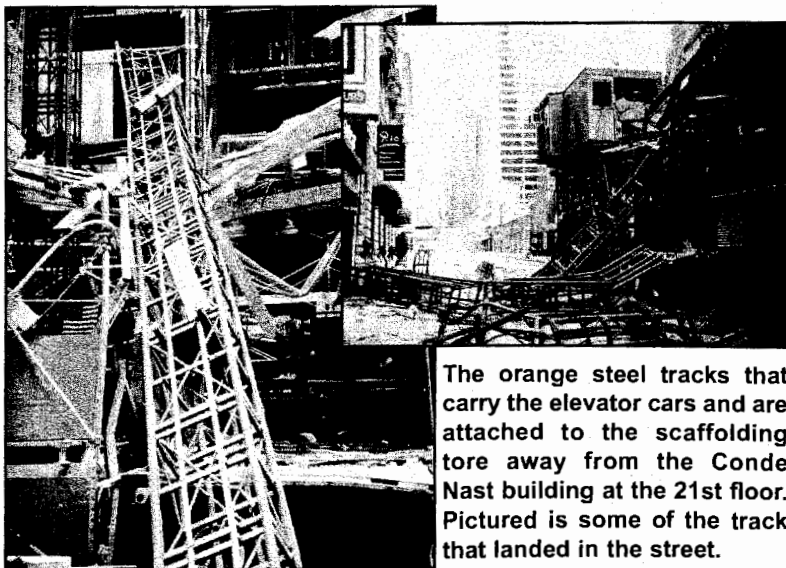
The orange steel tracks that carry the elevator cars and are attached to the scaffolding tore away from the Conde Nast building at the 21st floor. Pictured is some of the track that landed in the street.

21st floor. The track from the upper floors pulled away and sections of it landed on the street, in a parking garage directly across from the building and in the rear of a nine-story building on 44th Street. The largest section crashed through the roof of the 12-story Woodstock Hotel, located across the street from the scaffolded building. It was this section that penetrated the reinforced concrete roof of the hotel and killed the elderly occupant of room 1202 on the top floor. Damage to the cars on the roof of the garage and a section of the roof was significant. The counterweight for one of the cars was imbedded deep into 43rd Street.

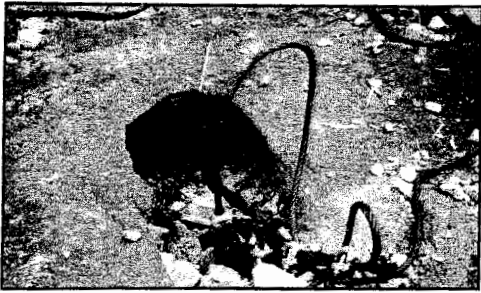
Counterweight for one of the elevators is imbedded deep into 43rd Street.

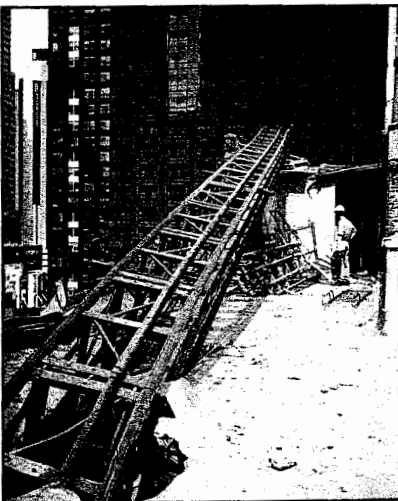
The largest section of track penetrated the concrete roof of the Woodstock Hotel, killing an elderly resident within.

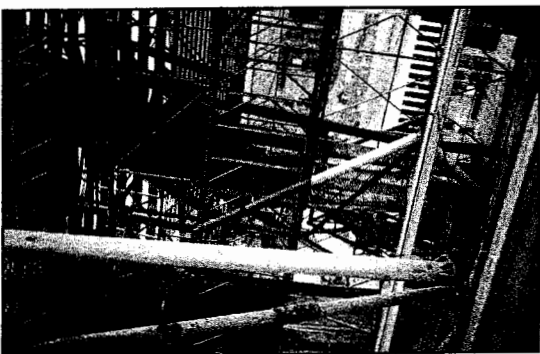
Horizontal supports to the scaffolding were examined and evaluated.

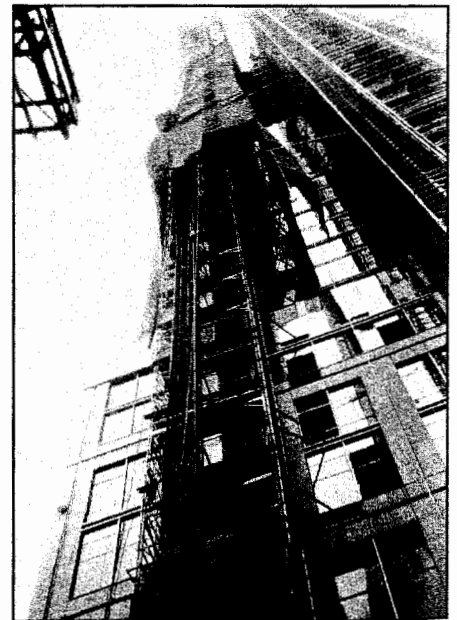
"Cocoon" encases the entire scaffolding in netting and prevents dislodged debris from falling to the street.

The first concern in developing the plan was to provide a means by which the entire scaffold (all 50 floors) could be secured in such a way to prevent loose debris, scaffolding, wood planks or piping to fall or scale away from the structure and become an airborne missile. Many ideas were considered, but the one selected was to completely encase the entire scaffolding in netting. This would produce a cocoon-type environment.

The first big question: How do you hold a netting that would be more than 730 feet high on four sides and secure it well enough so it wouldn't become a giant sail? Every detail of the design was taken into consideration--weight bearing, support cable size, methods of securing and putting it in place--and given serious thought. It was decided that a box 36 feet square would be needed to support the curtain. What would hold the

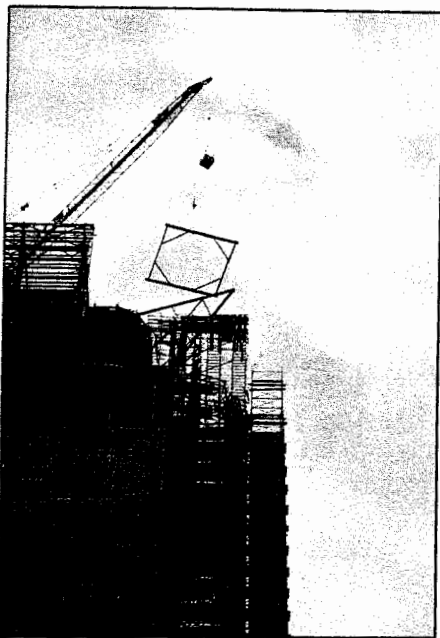
**Structural steel box and "A" frame are hoisted into position.**

box? An "A" frame was designed and fabricated on the roof and set into place at a 28-degree angle over the scaffolding. Both the "A" frame and box were made of structural steel.

Calculations for these designs included a safety factor. The box was hung from the "A" frame with four steel cables attached to a ring on the "A" frame. The next step involved securing cables to the box from which the netting would be

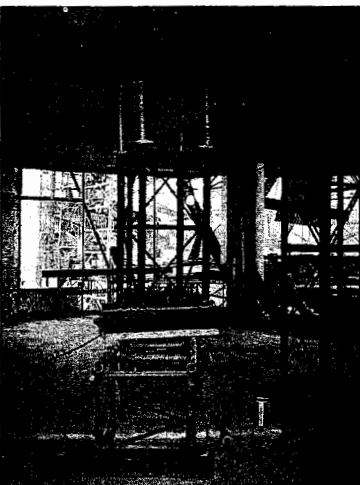
**Needle beams were used to support the scaffolding. For every foot of beam out from the floor, it was necessary to keep a foot and a half in on the floor.**

assembled by using the five-foot sections of what was used as tracks of the elevator hoist. Each section weighed 250 pounds and they were bolted together to form the beam. The needle beams then were placed out and under the collapsed scaffolding. For every foot of beam out from the floor, it was necessary to keep a foot and a half in on the floor. A 20-foot beam placed under the scaffold would have 30 feet back on the floor area. The section of beam back on the floor area had to be secured properly and shored to maintain its stability and

prevent it from tipping over. These needle beams were strategically placed on floor areas where they would provide the most support.

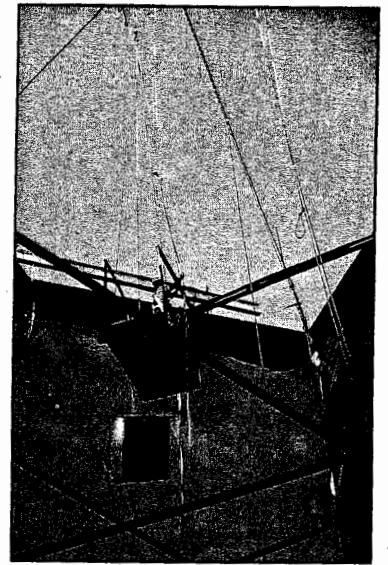
**Man baskets were secured to the crane's main line.**

Construction workers operated in man baskets secured to the crane's main line. FDNY members used handie-talkies to relay information to the workers in the baskets. Additionally, construction workers were directed by hand signals to ensure their safety as they attached these cables to the box.

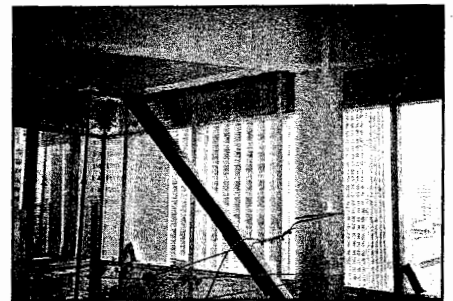
**Corner bracing of steel shoring was necessary to support the additional weight of the needle beams.**

Additionally, because of the design of the building, it became necessary to provide additional shoring to the floor areas. The corner areas were provided with steel shoring to support the additional weight of the beams. Engineers also were concerned about the stress being placed on all floors from the collapsed scaffolding.
