# Collapse on Adelphi Street

BY RAY DOWNEY

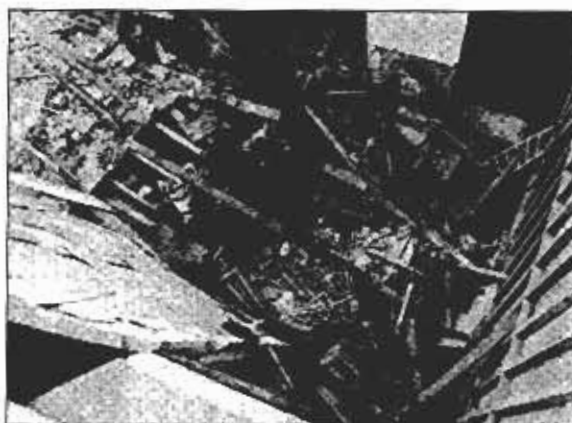
Three floors of the structure tumbled, pancake fashion, and came to rest on the first floor. All hope of rescuing the victim (center) rested on the possibility that individual voids had been formed by the unstable debris.

Now the rescue leader decided the effort would proceed from the top and front—from the top because the quickest access is gained that way in pancake collapse situations; from the front because, on that side, access to the victim was aided by the existence of voids formed by small, individual lean-to configurations (see drawing). Fortunately, supporting beams and columns in the building's full cellar had been completely replaced in the early stages of renovation. This kept the building from collapsing all the way into the basement, and allowed the rescuers' tunneling to begin at the first-floor level.

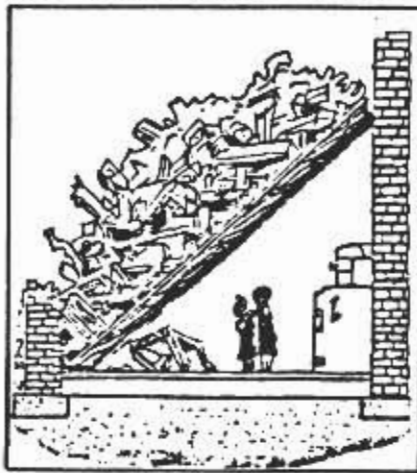
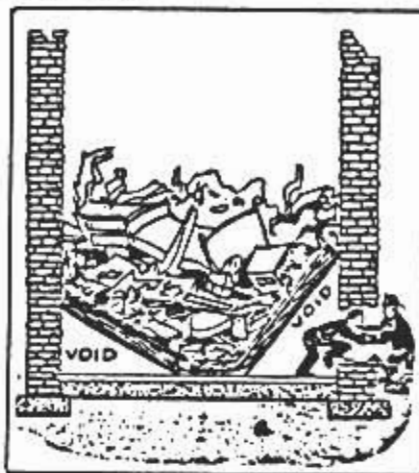
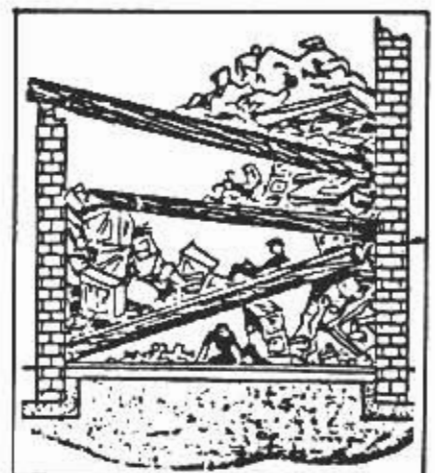
## The Three Types of Collapse

Lean-to collapses (left) are caused by walls falling away from floors or floors sagging and stretching beyond their supports. V-shaped collapses (center) are caused by overloading floors during occupancy changes or firefighting efforts. Pancake collapses (right) occur when a collapsing upper floor hits floors beneath and causes them to fail in turn. (Drawings used with permission of WNYF Magazine, Fire Department of New York City.)
